Illicit Discharge Detection and Elimination NHDES Merrimack River Basin Investigations

Nashua / Manchester Stormwater
Coalition Meeting
February 13th 2018

Stephen C Landry
NHDES – Water Division
Watershed Assistance Section

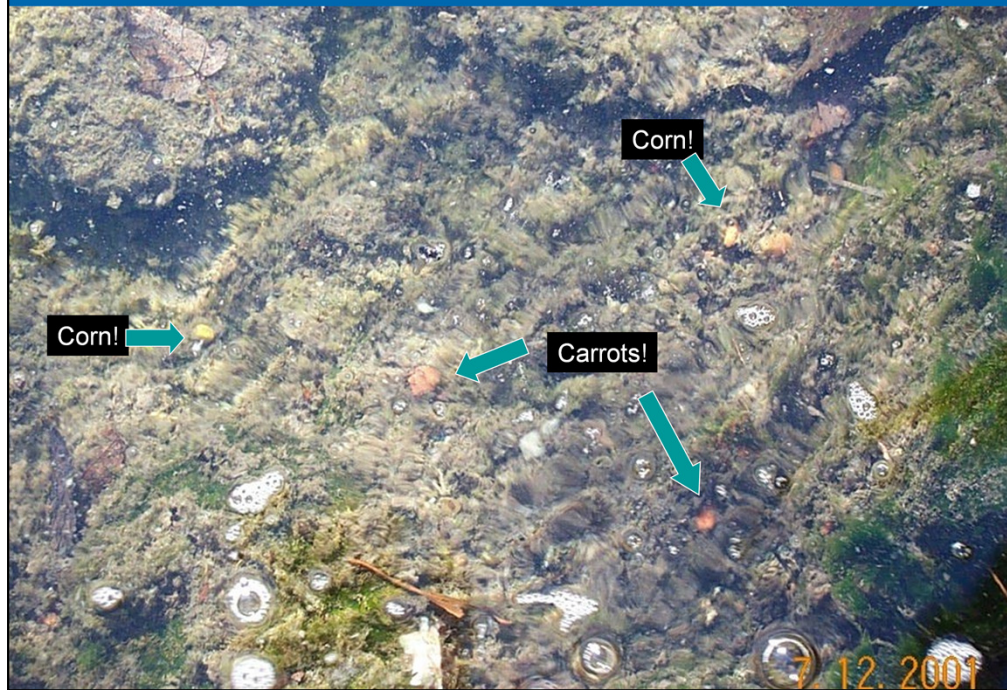
If you find Veg-All floating underneath an outfall, you probably do not need to waste money on a bacteria sample!

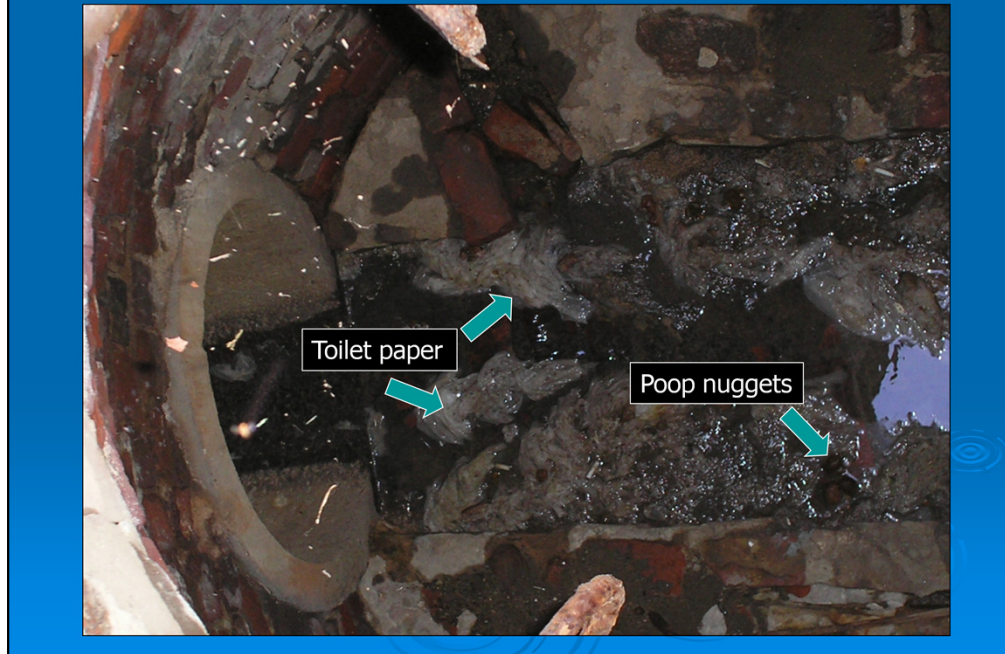
...or, if you see toilet paper and fecal matter, save your lab funding for later.

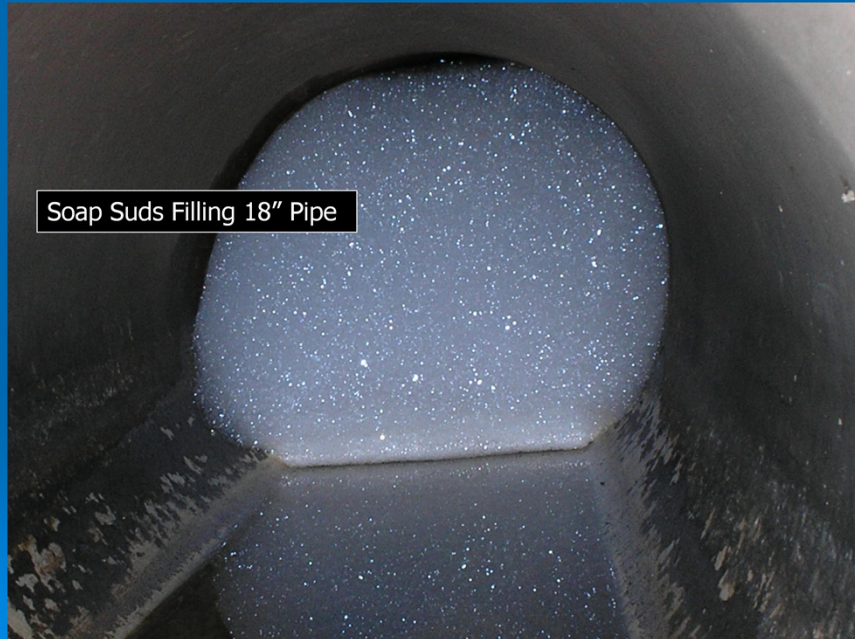
Some optical brightener testing may be in order here...

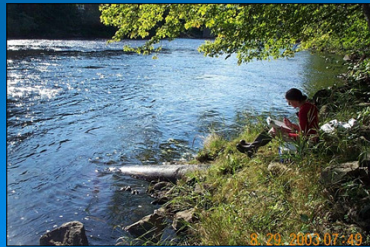
- A DES IDDE survey documents outfall and dry weather discharge
- Sample collected at outfall on Pemigewasset River

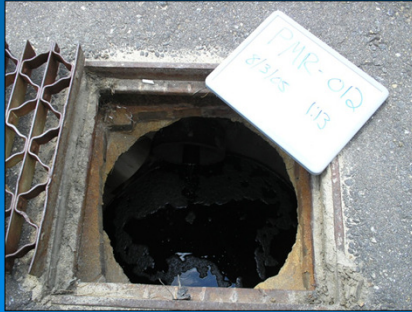
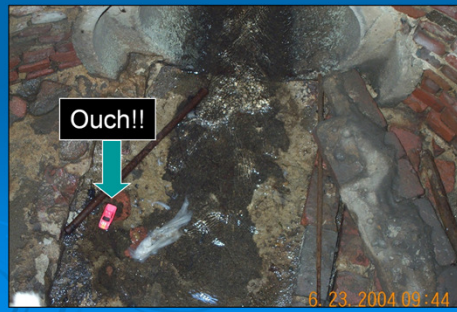
- E.coli results were $> 2,000$ cts/100mL
- Source tracking up the drain line reveals evidence of illicit discharge to MS4

- Review of sanitary sewer and storm sewer lines reveals a missed connection
- Dye testing of house confirms illicit source
- City of Franklin covers expense of sewer connection
- Homeowner refused to cover expense of interior hook-up to sewer line (sewer/water bills)
