Illicit Discharge Detection and Elimination: Merrimack and Seacoast Basin Investigations

Seacoast Stormwater Coalition
Meeting

June 27th 2018

Steve Landry & Rob Livingston
NHDES – Watershed Watershed
Assistance Section

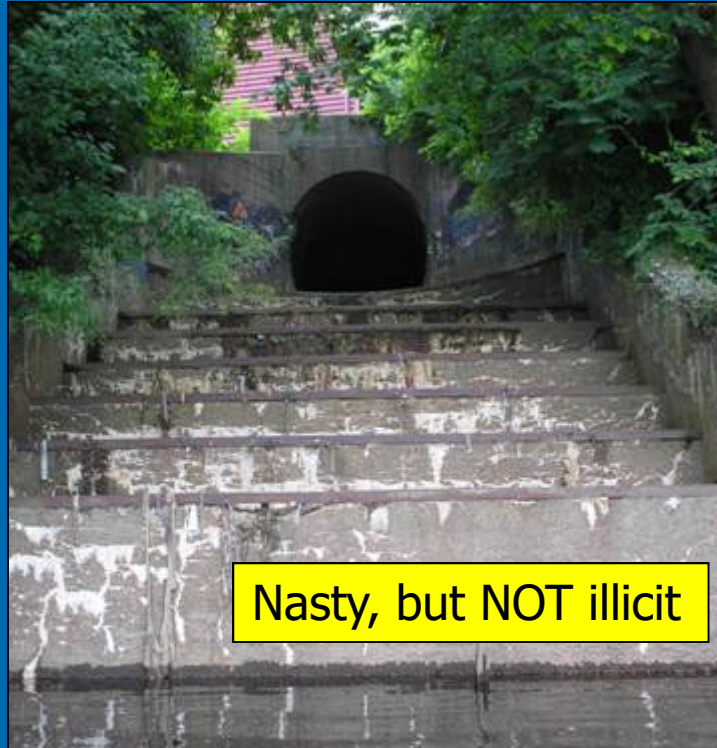
Nasty, but NOT illicit

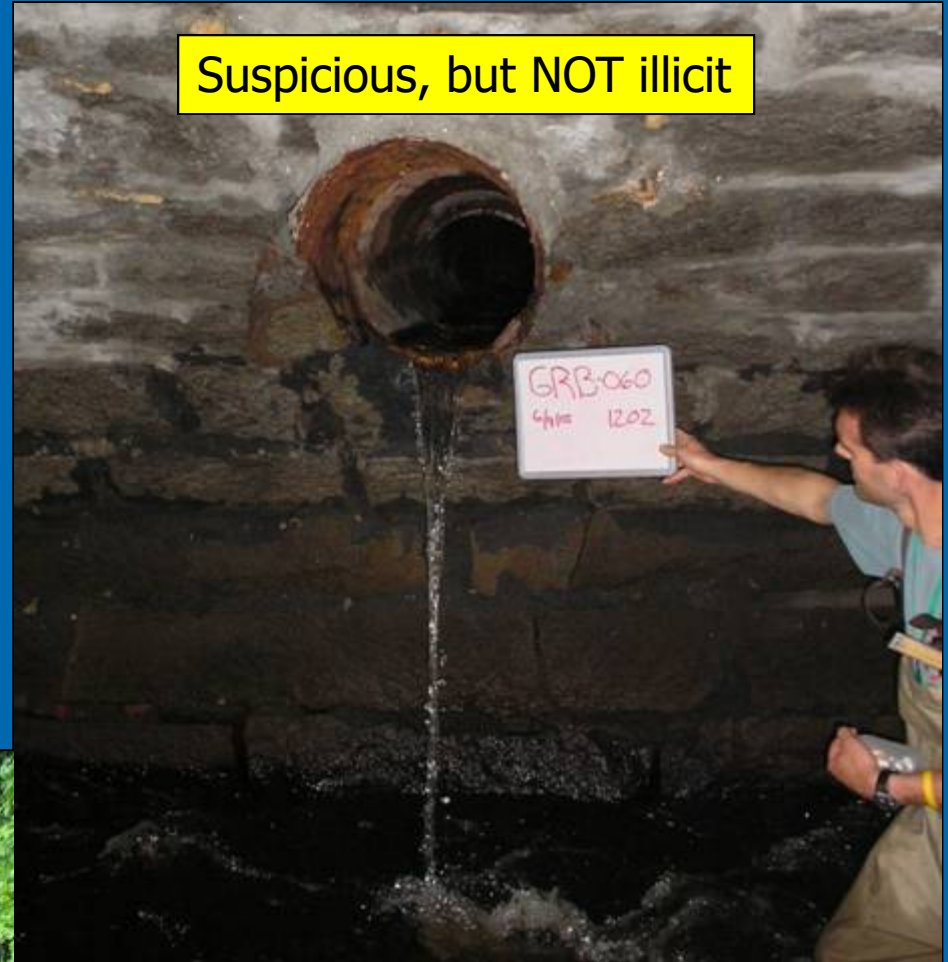
Suspicious, but NOT illicit

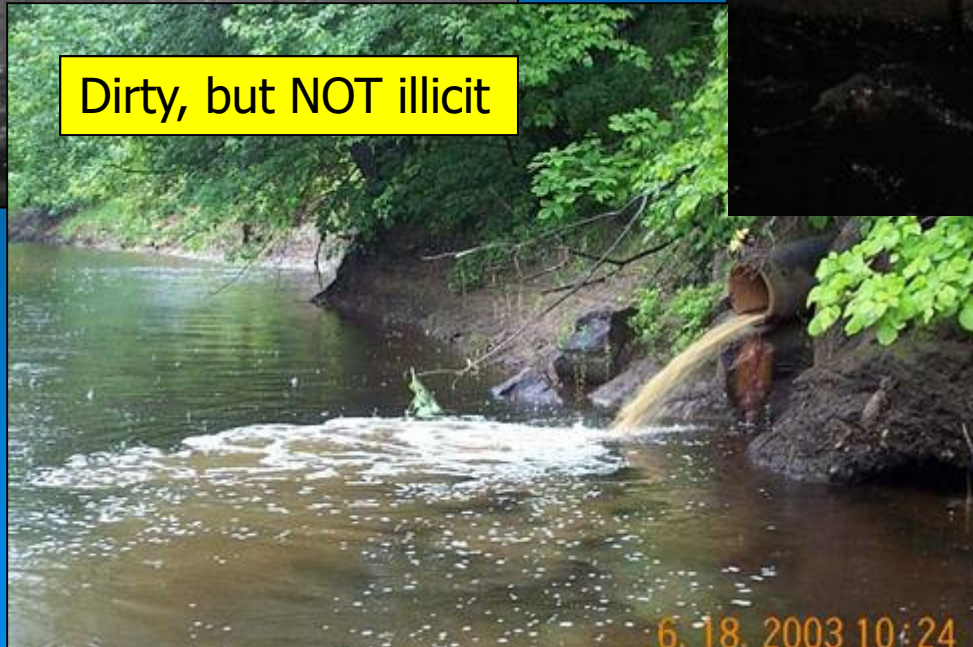
Dirty, but NOT illicit

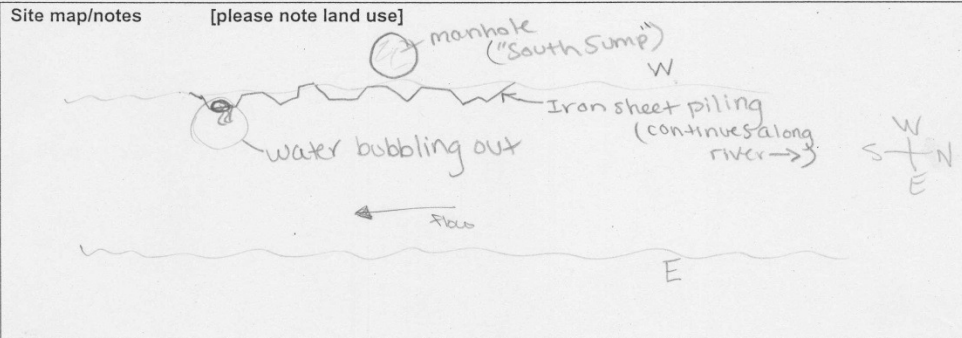
red clay asbestos other: sheet piling

Odor: none sewage oil/gas laundry sulfide other: petroleum

Deposits/stains: none black brown yellow white describe: petroleum sheen

Sample ID #	Date/Time Sampled	Parameter	RESULTS	Other/Notes
MER-1261 300	6/16/03 10:20am	E. coli	<10 cfs/100ml	
MER-305

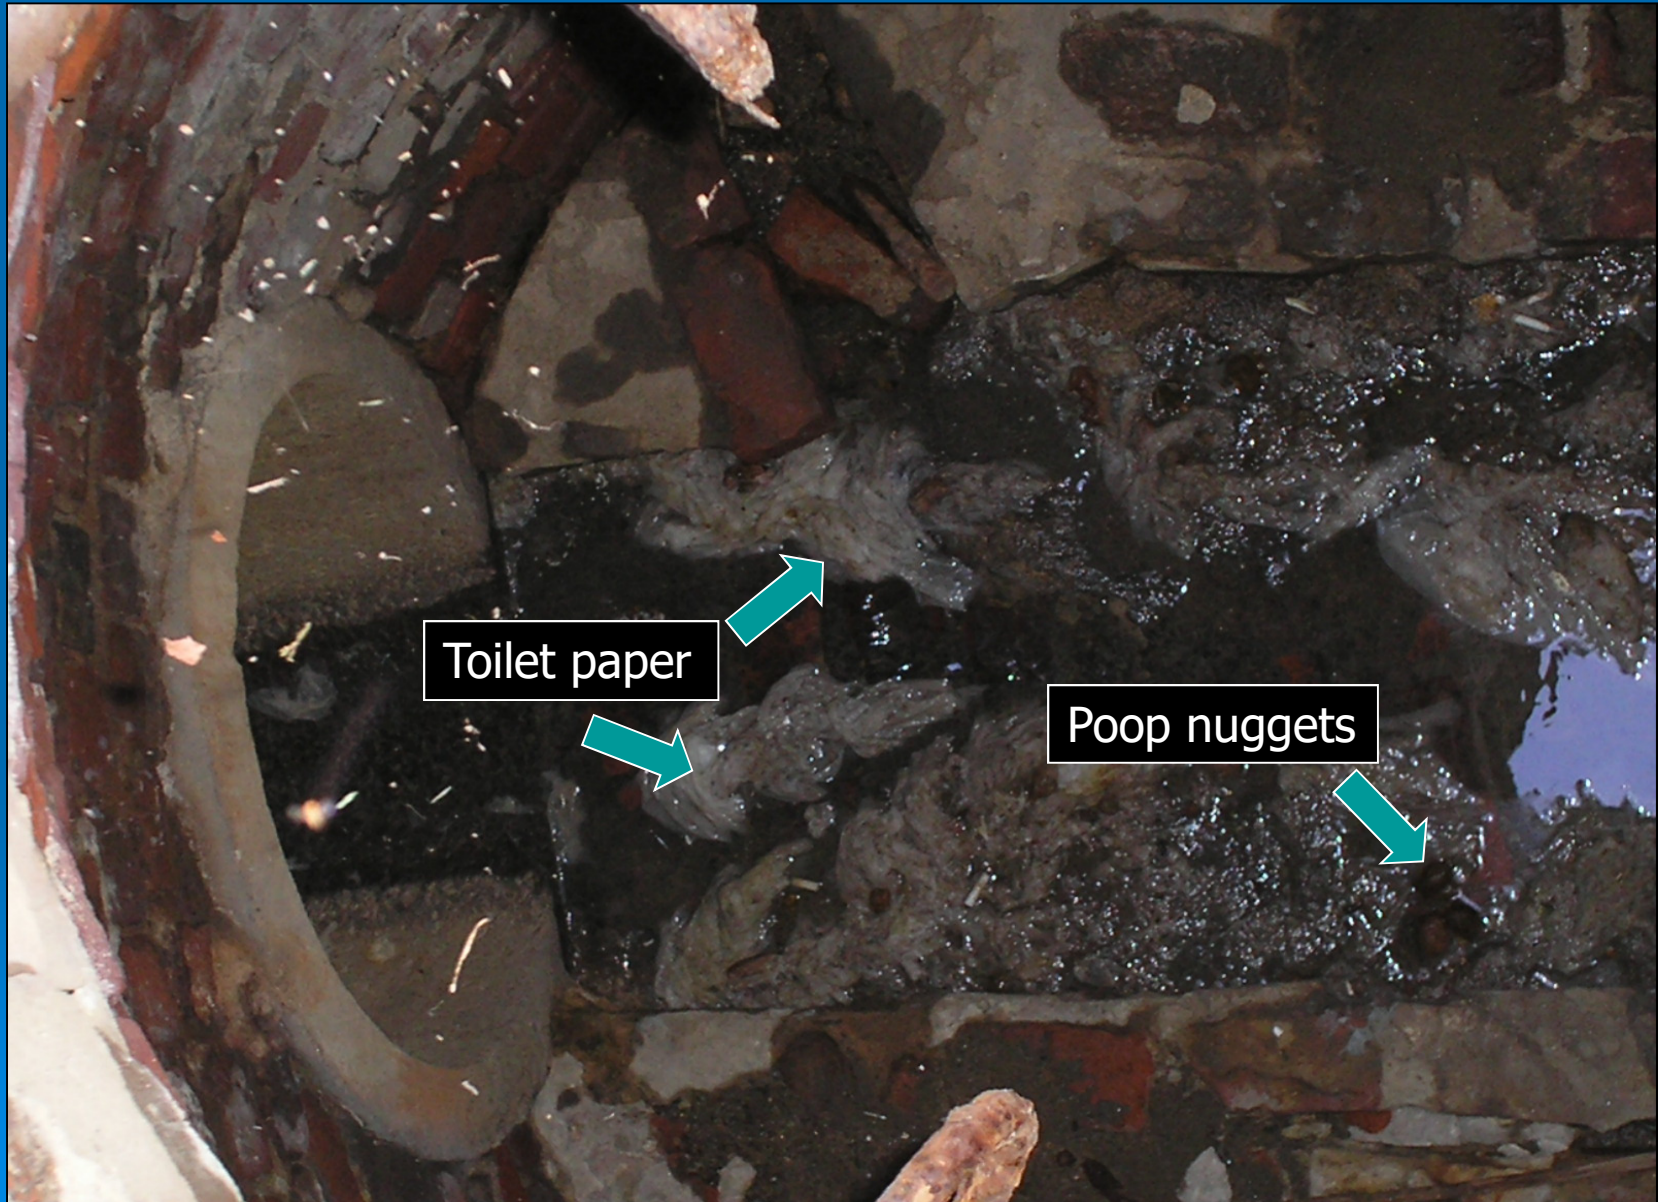
Toilet paper

Poop nuggets
