# STREAM CROSSING REPLACEMENTS FOR AQUATIC RESTORATION AND MITIGATION

Cheryl Bondi, PhD  
Flood Risk Specialist  
NH Department of Environmental Services

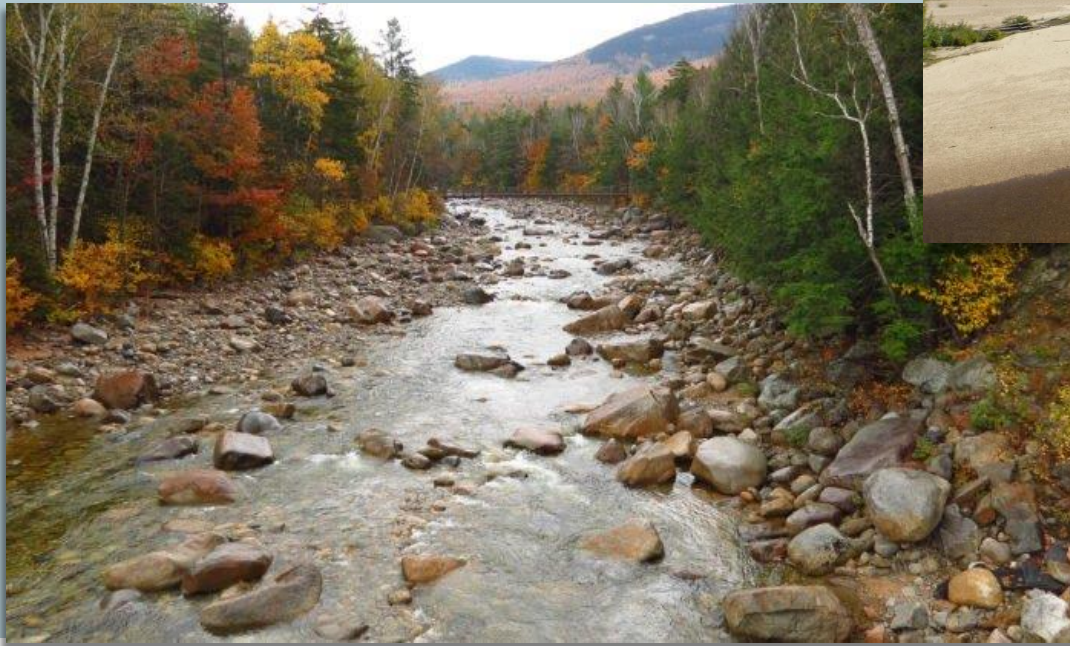
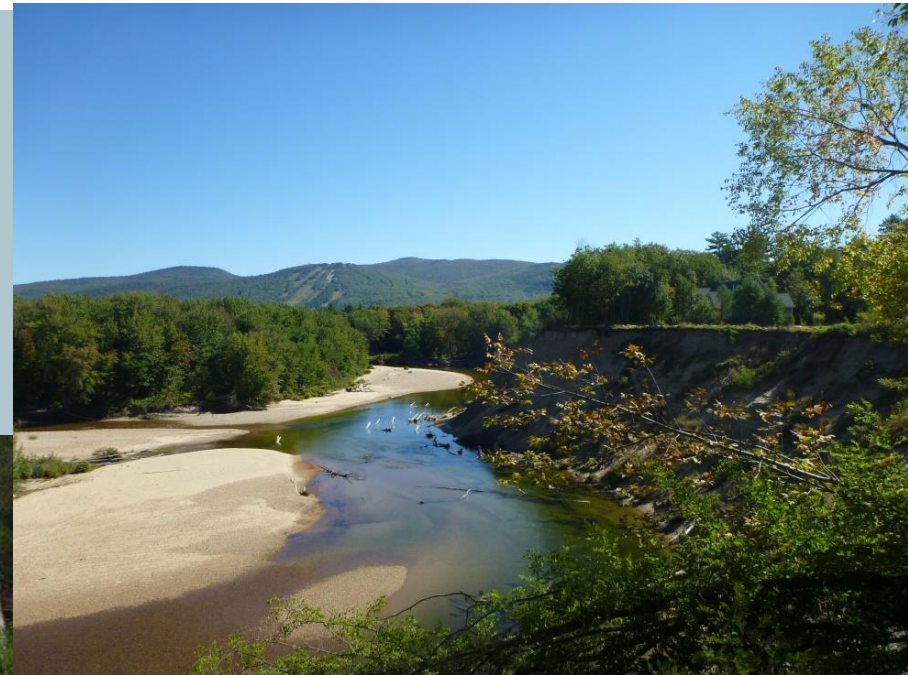
## Geomorphic Compatibility

- How well does a crossing fit the natural form and sediment transport processes of a river?

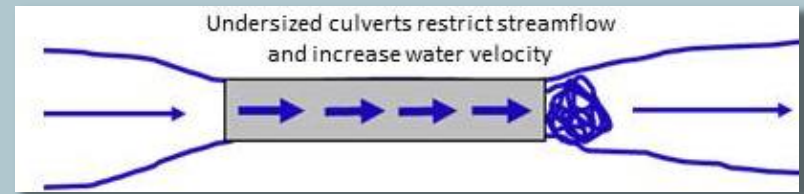
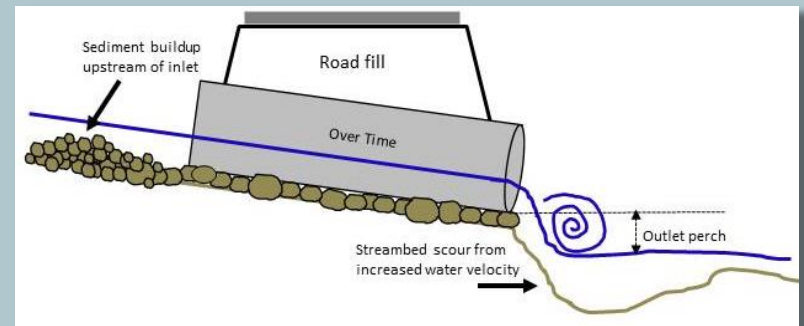
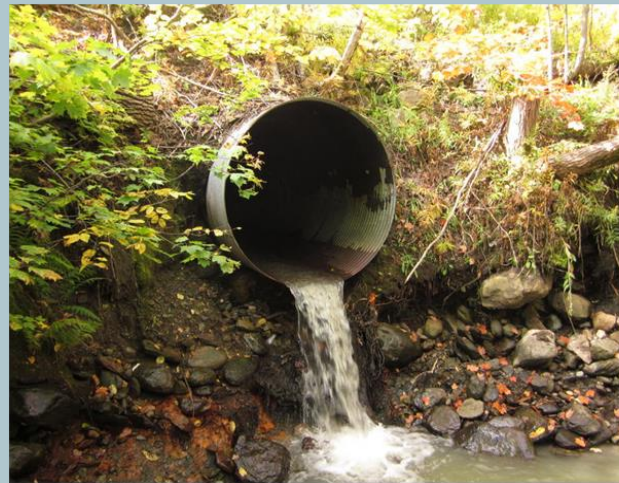
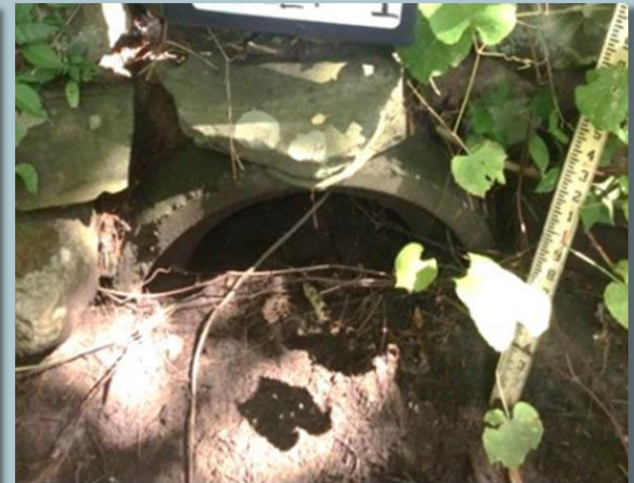
- Undersized culverts increase water velocity
  - “Fire hose effect”
- Over time crossings become:
  - Clogged US
  - Channel widens upstream
  - Bank erosion
  - Bed scour
  - Perched

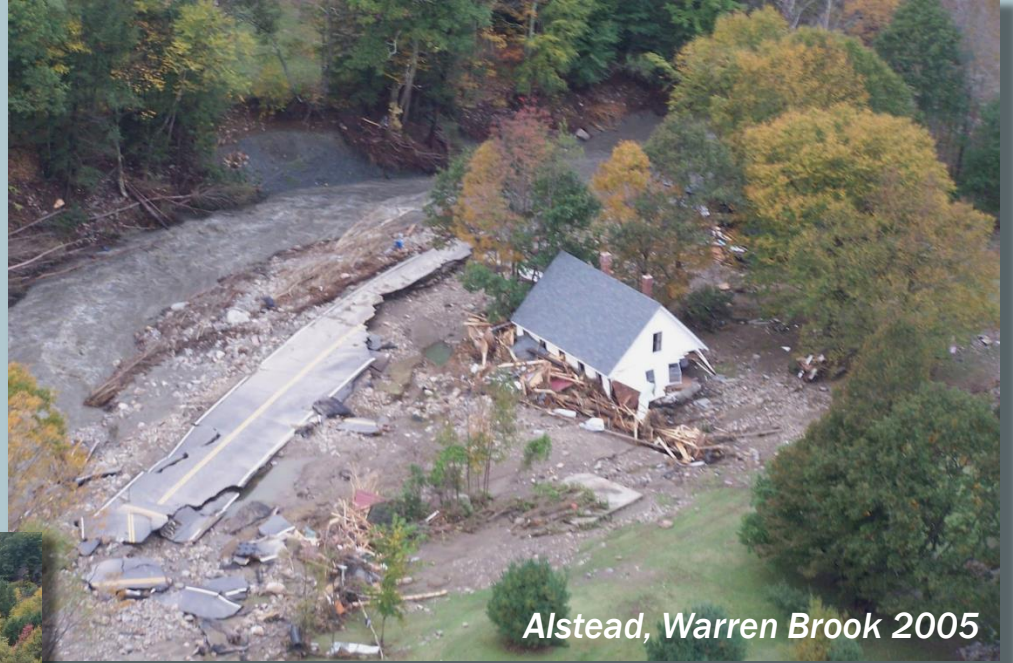
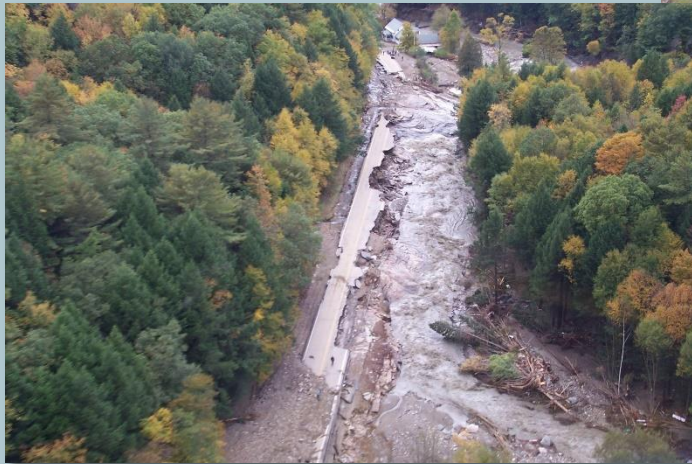
- Ponding can occur upstream of undersized culverts
- During high flow events send a wall of water crashing downstream
  - Catastrophic damage

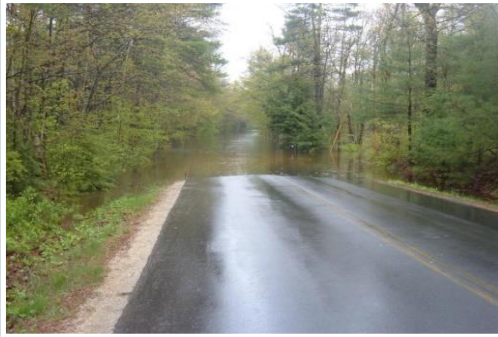
Water overtops a culvert in Lee and the river crosses the road

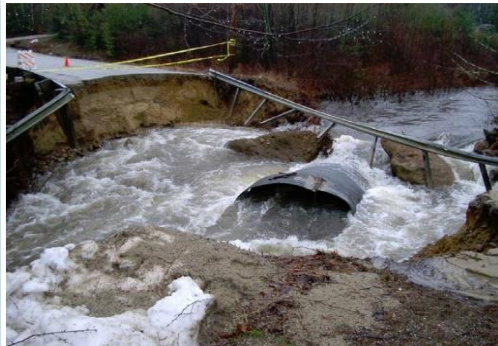
Culvert failure on Blake Brook in Epsom

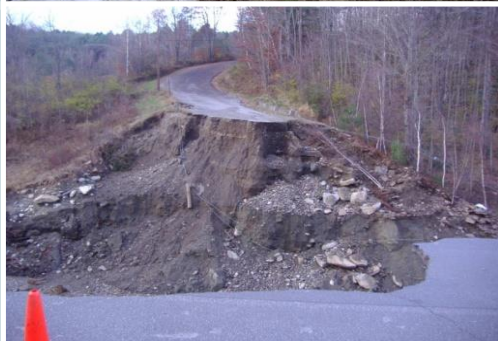
Catastrophic culvert failure in Alstead lead to loss of life

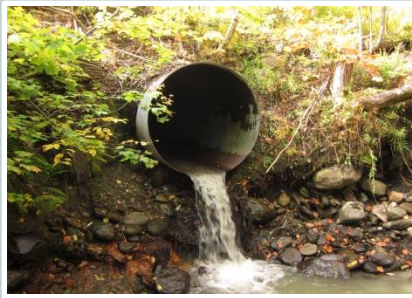
- Perched outlet
- No resting pool
- Lacks natural substrate

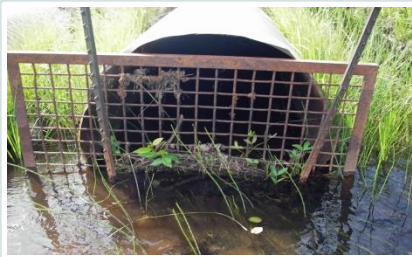
- Screen is barrier
- Clogged with debris

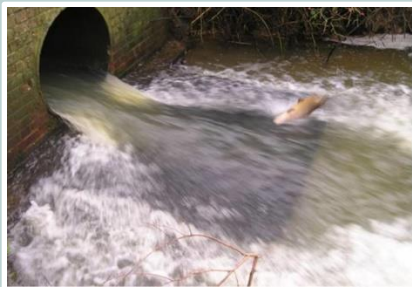
- Extremely high velocity

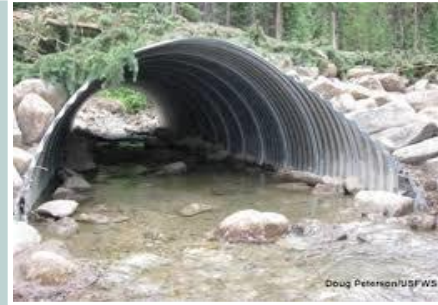
- Low velocity
- Sufficient water depth
- Natural substrate

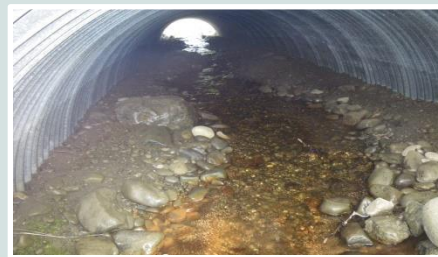
- Channel banks enhance animal passage

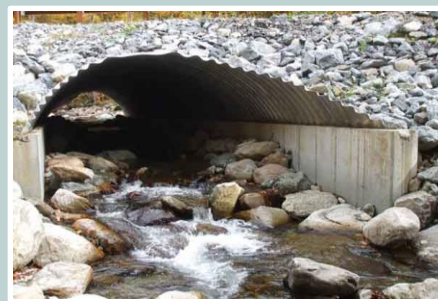
- Natural substrate throughout the structure
- Step-pools

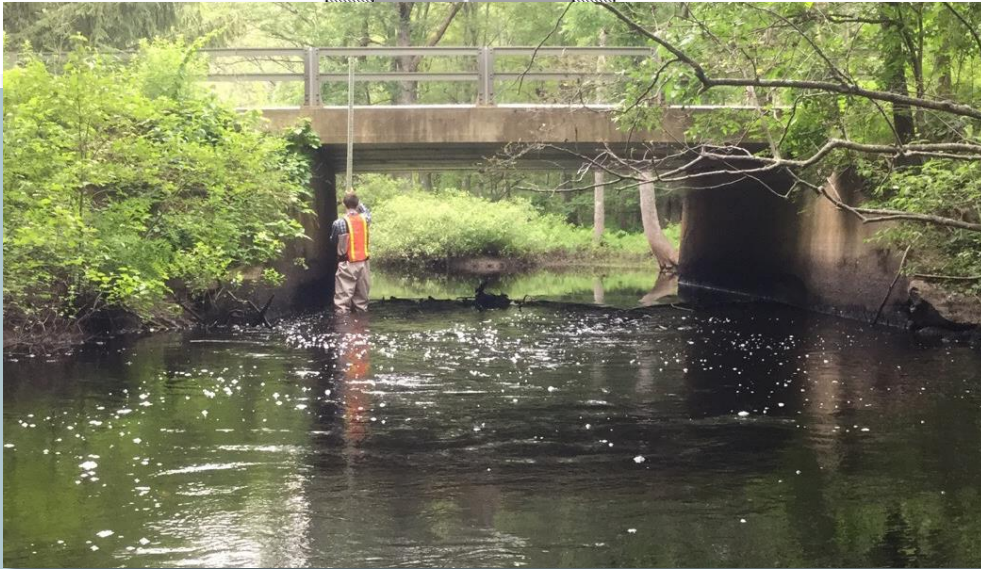
## ■ Geomorphic Compatibility

- Collect data on stream channel size and shape
- Observations of bank erosion and bed scour recorded
- Sediment deposition

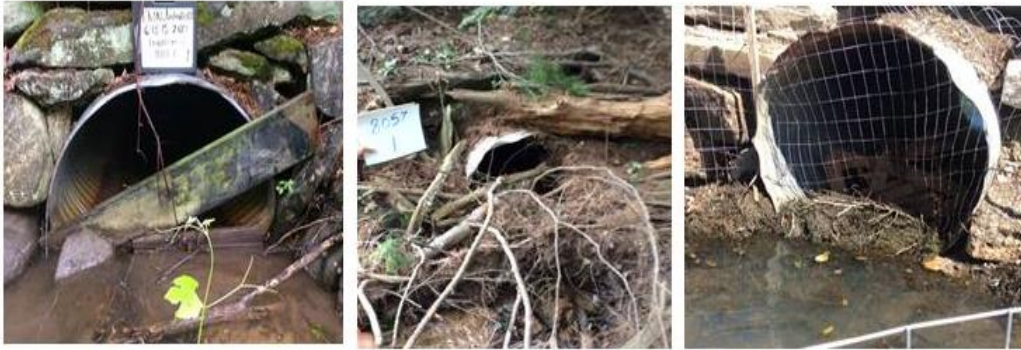
## ■ Aquatic Organism Passage

- Inlet obstructions
- Outlet grade
- Substrate and water depth throughout the structure

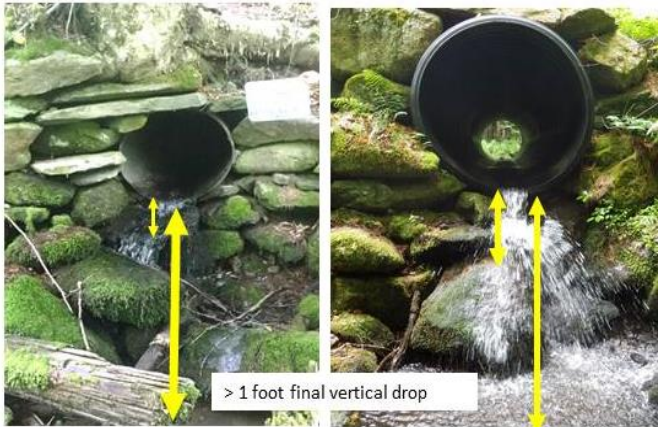
Freefall

> 1 foot final vertical drop

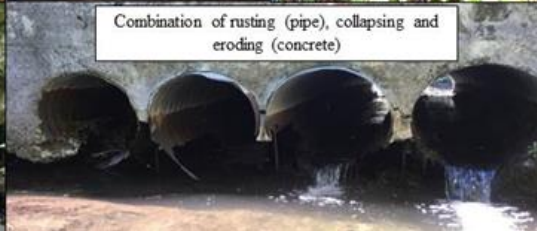
Combination of rusting (pipe), collapsing and eroding (concrete)

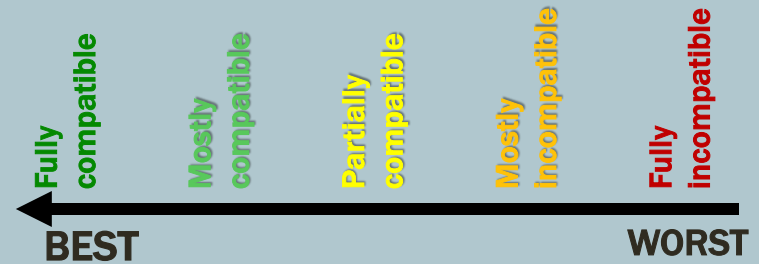
## ■ Geomorphic Compatibility

- Scores reflect how well the crossing fits river shape and if it impedes sediment transport

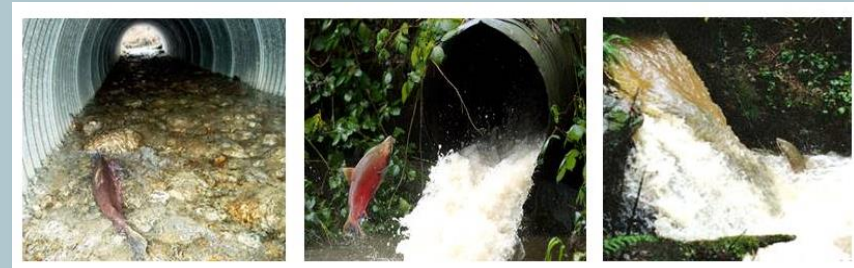
## ■ Aquatic Organism Passage

- Describes whether structure is likely passable by fish and other animals

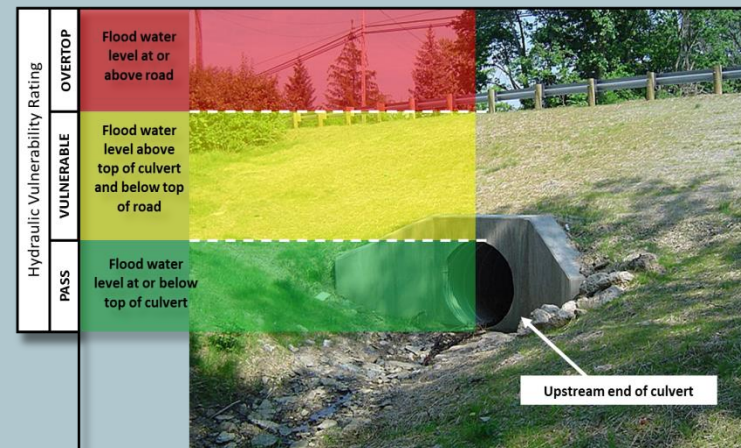
## ■ Hydraulic Vulnerability

- Hydraulic Capacity Model based on runoff predictions and structure data
