Illicit Discharge Detection and Elimination: Merrimack and Seacoast Basin Investigations

Seacoast Stormwater Coalition
Meeting

June 27th 2018

Steve Landry & Rob Livingston
NHDES – Watershed Watershed
Assistance Section

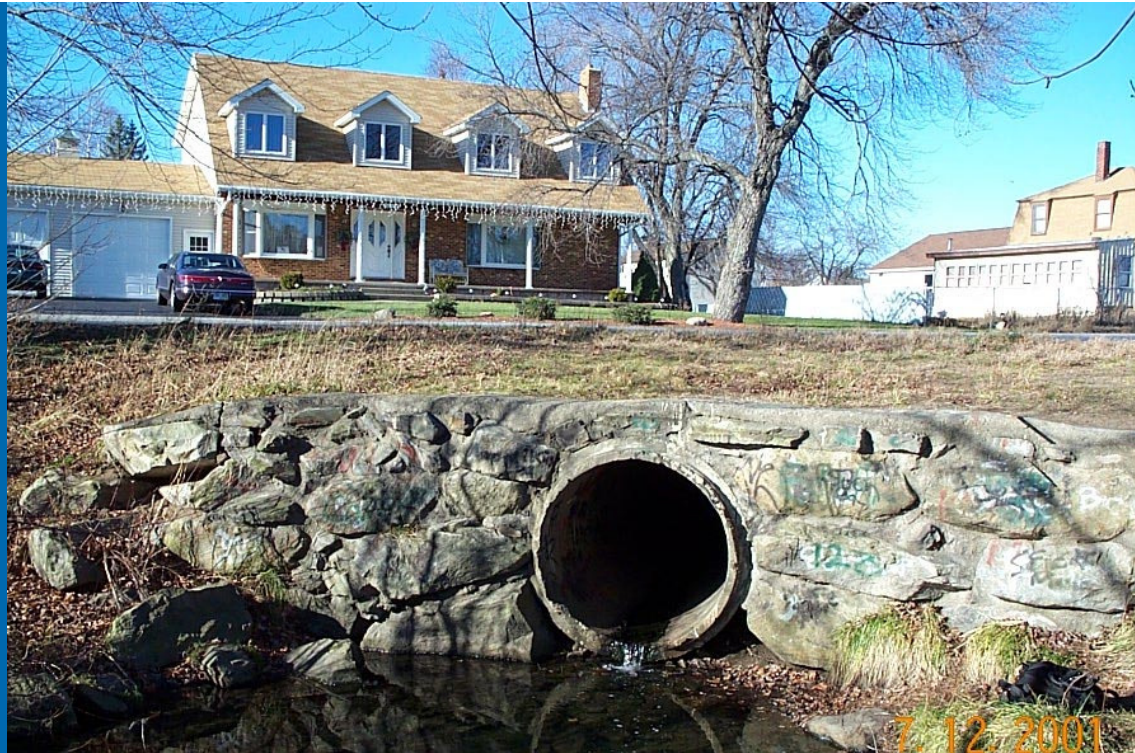
2003 MERRIMACK SHORELINE SURVEY SHEET
NH DES Watershed Management Bureau, Watershed Assistance Section

Street and location information: 22 Cabot Road - Behind Botucci's Field measurements (temperature, conductivity, etc.): _____

Physical Observations: pipe box culvert seep swale diameter: 18"
 Outfall material: granite cast iron corrug. metal corrug. plastic concrete white PVC green PVC
 red clay asbestos other: _____

Functioning? no possibly yes Note condition: Good
 dry moist drip trickle moderate standing water
 sewage oil/gas laundry sulfide other: _____

Color: none gray brown yellow green other: _____
 Turbidity: none cloudy opaque comments: _____
 Floatables: none sewage oil sheen soap suds other: _____
 posits/stains: none black brown yellow white describe: Green-Brown (algae)
 veg. growth: normal excessive inhibited describe: _____

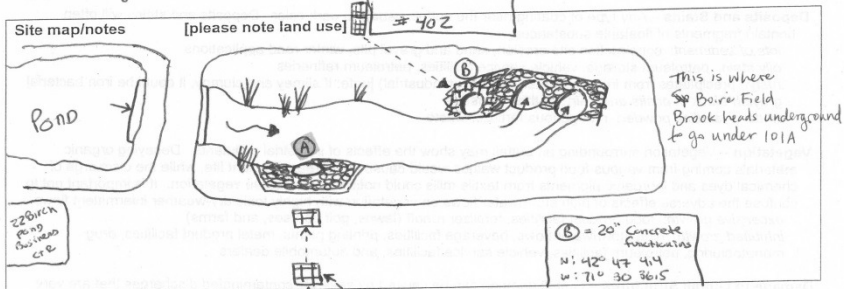
Date	8/22/03	Time	1346	Contact:	Andrea Donlon (x 8862) or Steve Landry (x 2969)
Town name	Nashua	Direct waterbody affected	Downstream waterbody affected MERRIMACK RIVER		
Collected by	S. Landry + A. Donlon	Rainfall/weather past 48 hours	Latitude/longitude N: 42° 47' 4.4" W: 71° 30' 38.7"		
Street and location information	Cotton Rd.	Field measurements (temperature, conductivity, etc.)

Outfall type: pipe box culvert seep swale diameter: 20"

Outfall material: granite cast iron corrug. metal corrug. plastic concrete white PVC green PVC

Functioning? no possibly yes Note condition: trickle moderate standing water

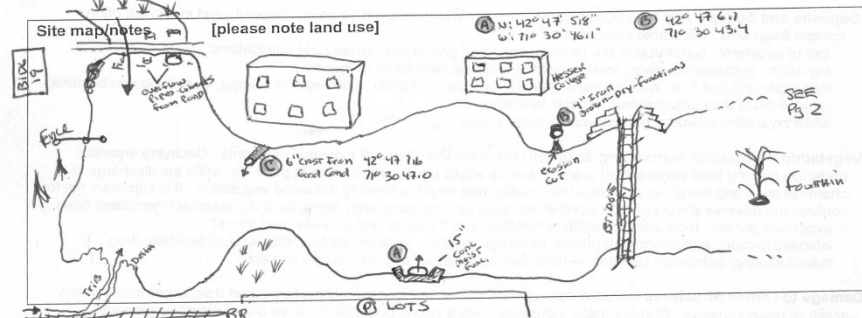
Date	8/22/03	Time	1121	Contact:	Andrea Donlon (x 8862) or Steve Landry (x 2969)
Town name	NASHUA	Direct waterbody affected	Downstream waterbody affected MERRIMACK RIVER - Pennacook		
Collected by	A. Donlon + S. Landry	Rainfall/weather past 48 hours	Latitude/longitude		
Street and location information	Cotton Ave - 22 Cotton Rd BIRCH POND BUSINESS CR	Field measurements (temperature, conductivity, etc.)

Sample ID #	Date/Time Sampled	Parameter	RESULTS	Other/Notes
(A) BFB-015				
(B) BFB-025				
(C) BFB-035

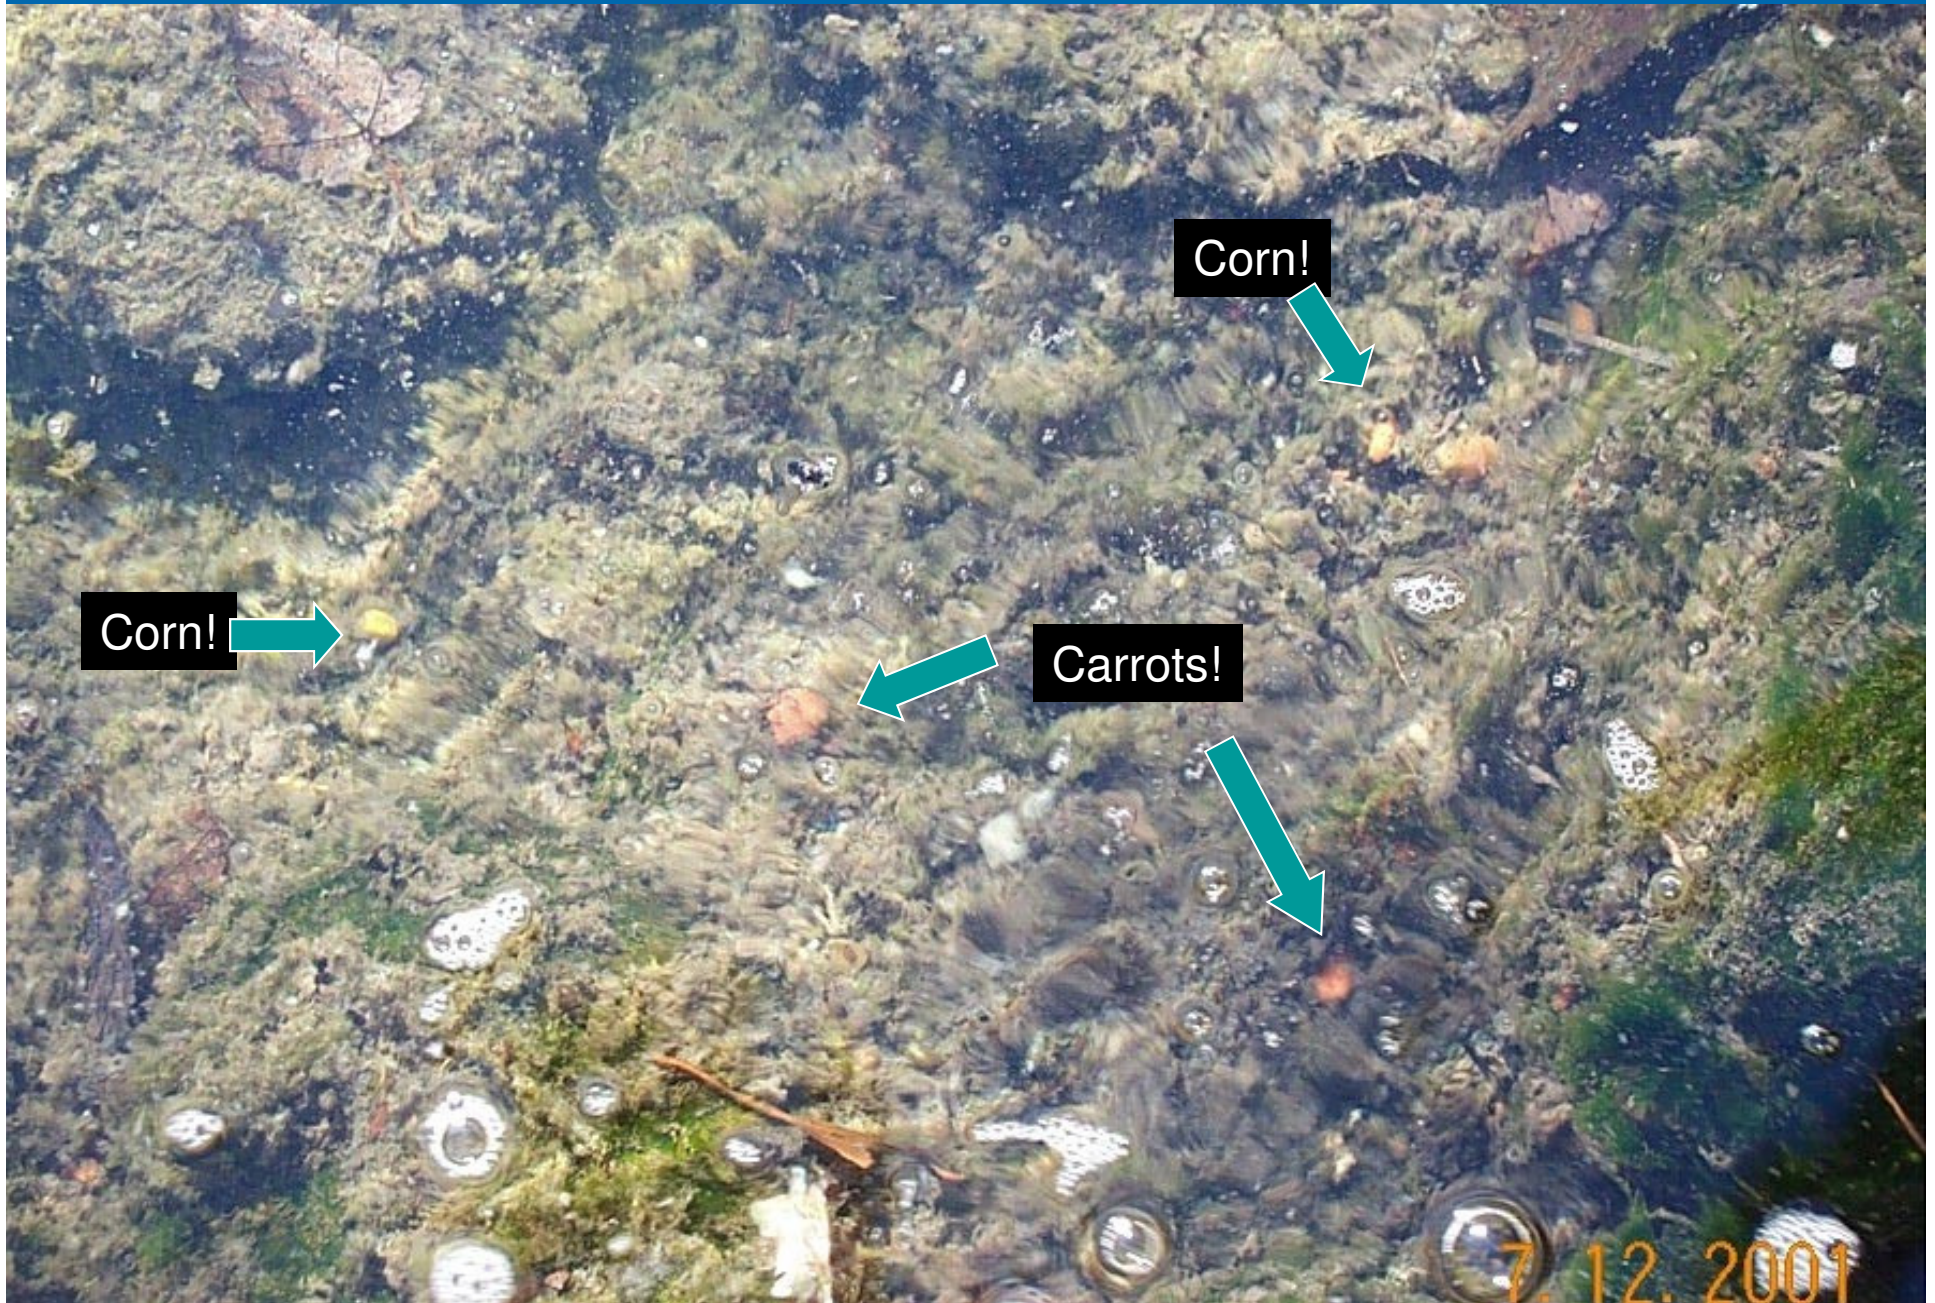
What do we mean by sampled if necessary?
